# Bus stop infrastructure – siting and design

## Joint position paper from Cambridge Area Bus Users and Living Streets Cambridge

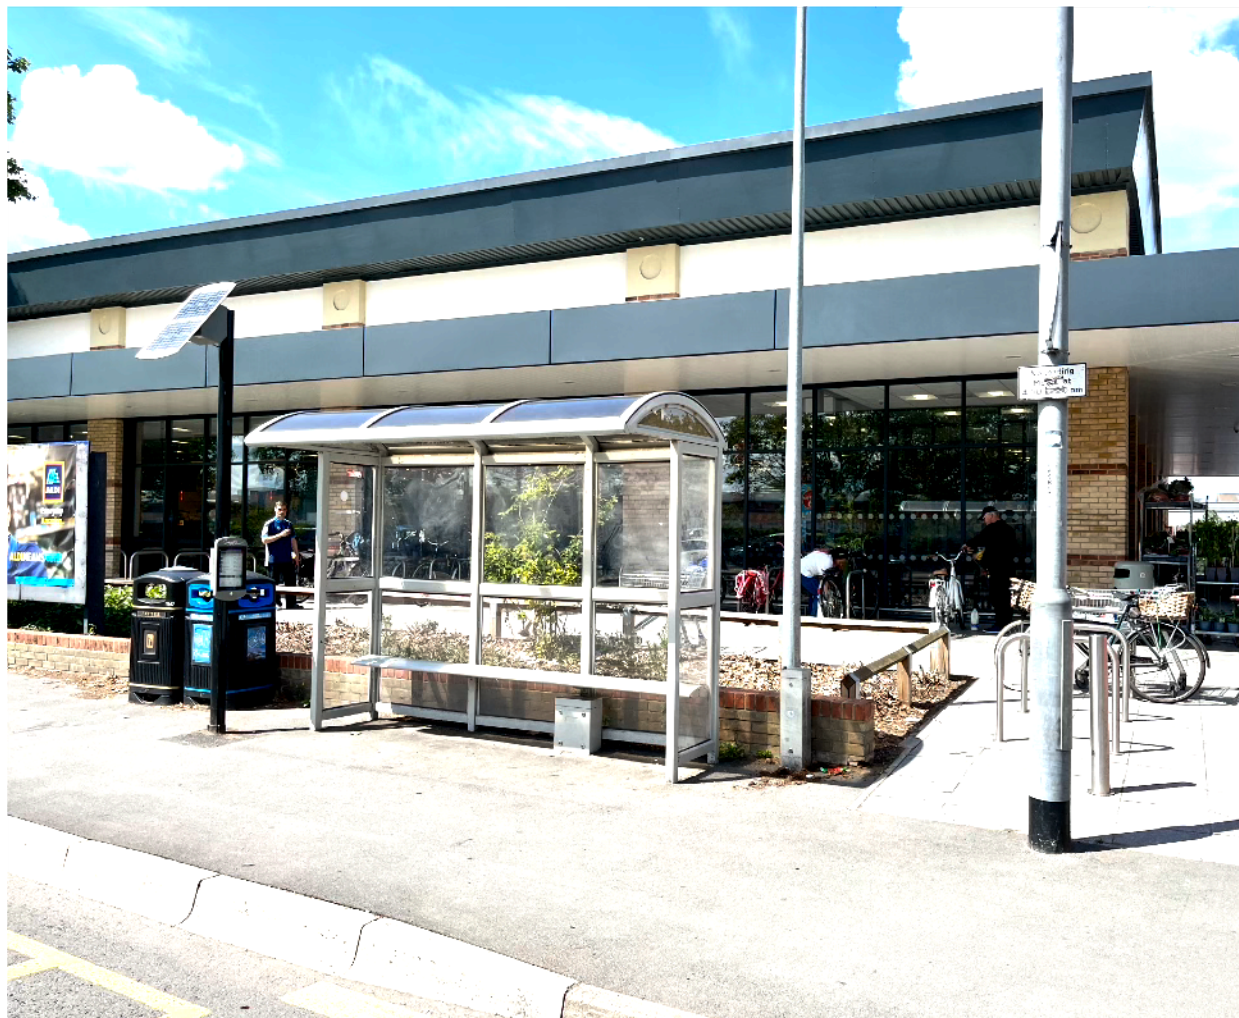
Stanley Road (outbound) 0500CCITY165 (outside Aldi, Newmarket Road)

- ❖ The shelter, with integral seating, is set back at the edge of the highway boundary.
- ❖ A bus stop flag has been mounted on an adjacent street-lighting column.
- ❖ RTPI, of e-paper type, is installed close to the shelter at the upstream end.
- ❖ There are no obstructions for passengers boarding/alighting.
- ❖ Well-sited litter bins do not obstruct pedestrians.
- ❖ Overall installation gives good access to accommodate a 'reference wheelchair' (DfT guidance) of 1.20 m length and deploying the associated 1.20 m manually-extended bus-mounted wheelchair ramp.

- ❖ There should be a lockable case for printed route/timetable information.  
*(This has since been installed.)*

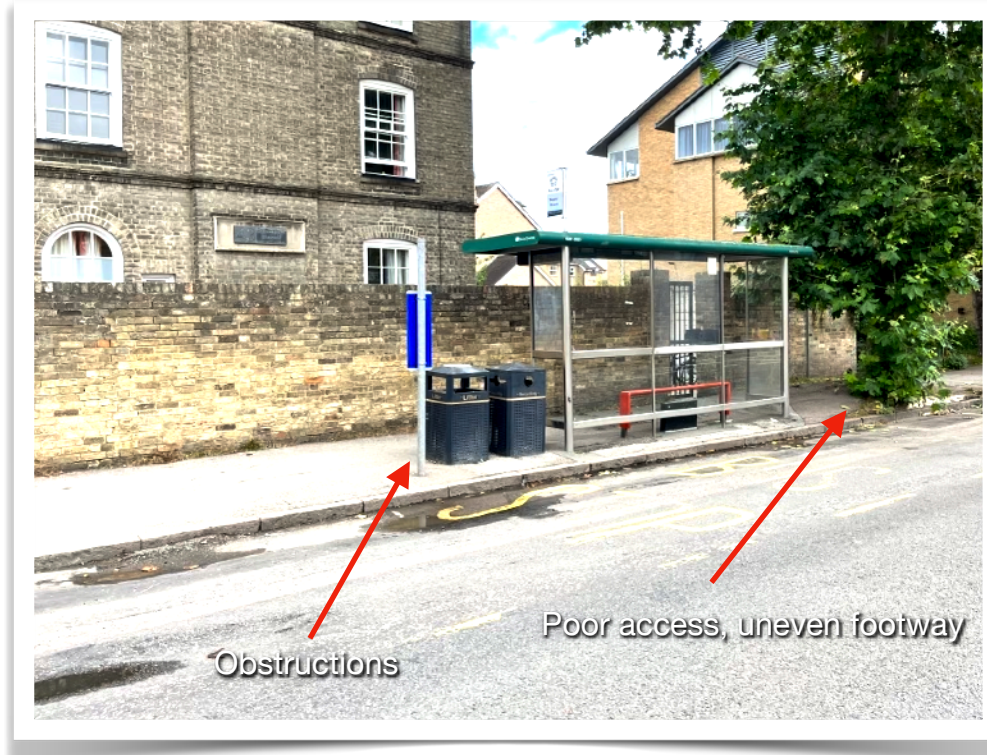
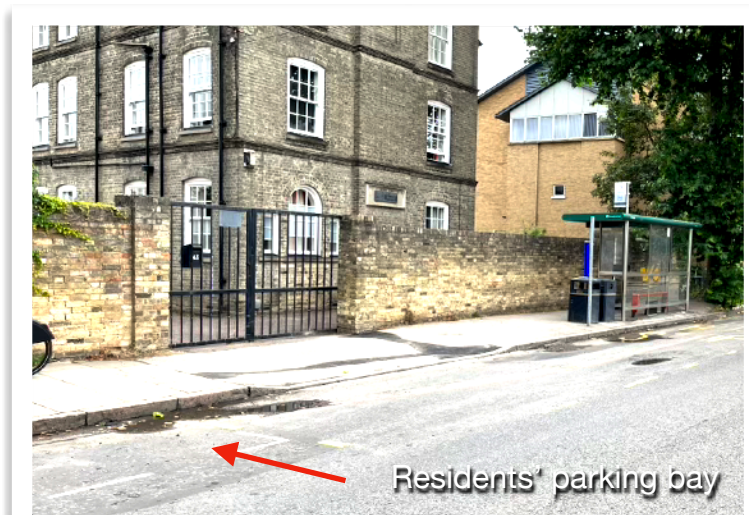
Napier Street (outbound) 0500CCITY102

- ❖ The shelter is adjacent to the bus stop carriageway-markings. However boarding from the downstream end would be difficult because of a nearby tree, which 'bushes' near its base in the growing season.
- ❖ At the upstream end of the shelter boarding/alighting is obstructed by a litter bin, a recycling bin and a redundant bus stop pole with no flag. *(The bins have since been removed.)*
- ❖ A nearby residents' parking bay, upstream, prevents buses pulling in close to and parallel to the kerb, creating difficulties for boarding, especially for users of walking aids and wheelchairs.

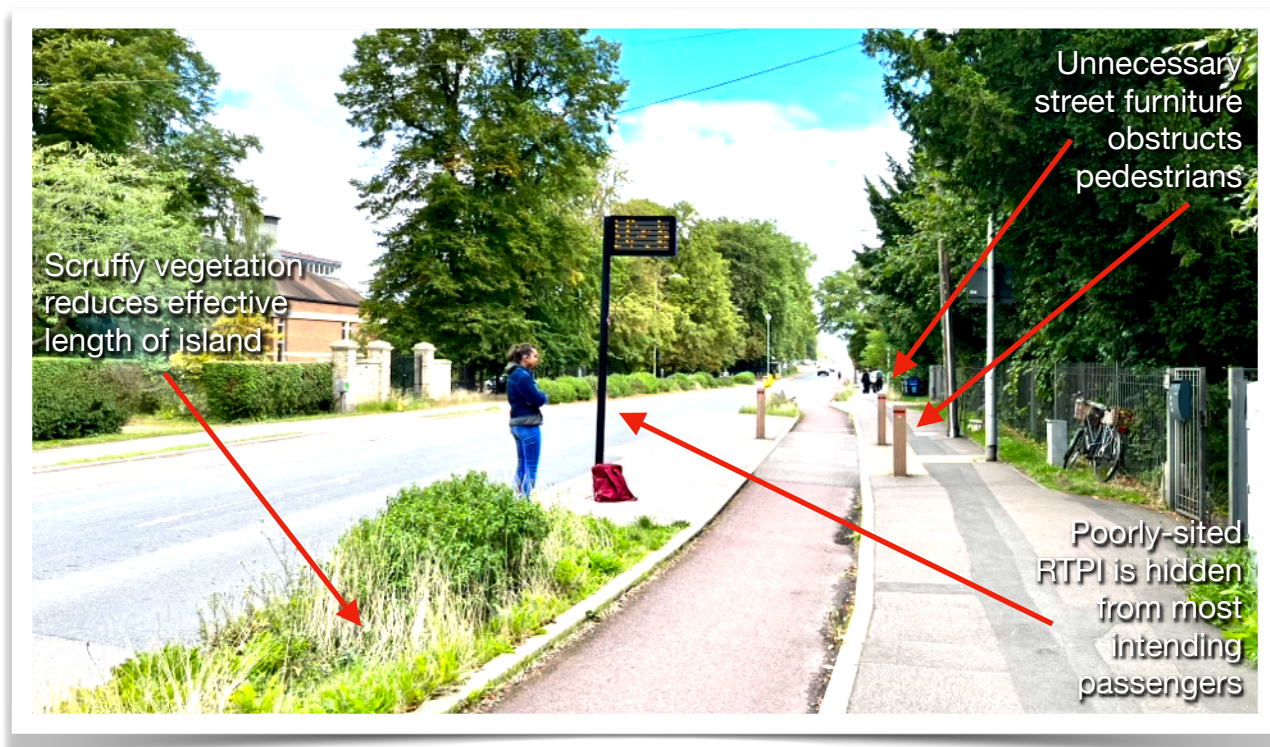
Blinco Grove (outbound) 0500CCITY036

- ❖ The width of the island is inadequate at 1.90 m. A user of a 'reference wheelchair' (DfT guidance) of 1.20 m length, mounting a 1.20 m manually-extended wheelchair ramp would need to reverse by approximately 0.50 m into the cycleway creating a collision hazard with cyclists.

- ❖ The length of the island – further reduced by rather untidy 'decorative' planting – is inadequate for a stop served by around 15 buses per hour.
- ❖ The island's area is inadequate for accommodating peak-time waiting passengers.

- ❖ The RTPI display, at the downstream end of the island, facing downstream, close to the 'decorative' planting, makes consulting the RTPI display difficult. *(This has since been corrected.)*

- ❖ No shelter or seating is provided.
- ❖ Navigating the crossing point for pedestrians from the footway is compromised by street lighting column L91SAN, a nearby wooden telecoms post and two on-footway (plus one on-island) short wooden posts bearing miniature warning triangles. These create a potential collision hazard for cyclists with little utility.

- ❖ The siting of this stop adjacent to street lighting column L91SAN and the installation of the two short on-footway wooden posts create a chicane-effect obstruction for wheelchair users.

- ❖ The footway width (2.00 m minimum upstream and downstream of the stop) is reduced by these hazards to 1.60 m (by upstream post) 1.75m (by street lighting column L91SAN) and 1.50 m (by downstream post).

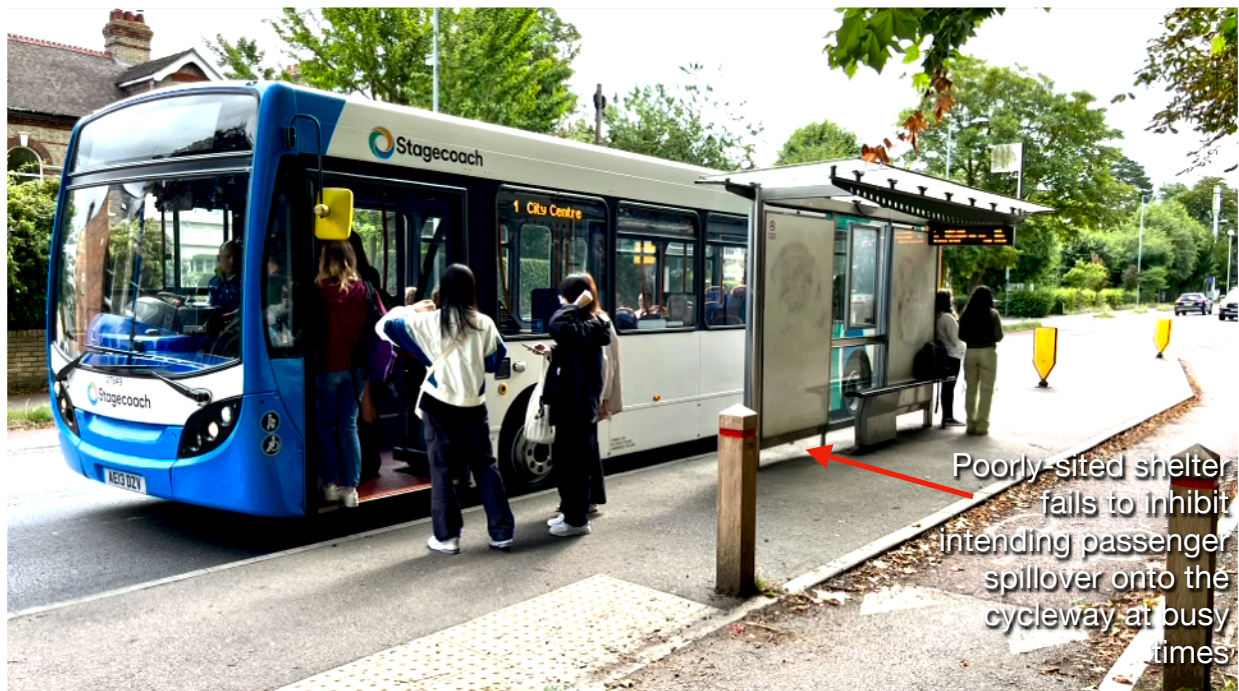
Blinco Grove (inbound) 0500CCITY064

- ❖ Siting of the shelter, with its wall close to the carriageway, set-back approximately 0.50 m, unnecessarily restricts access to buses.
- ❖ The wall of the shelter should back onto the cycle track, not the carriageway, to facilitate boarding and to inhibit spillover of waiting passengers onto the cycleway at busy times.
- ❖ The shelter's integral pole and bus stop flag is unused.
- ❖ An unnecessary pole and flag has been installed on the downstream end of the island.
- ❖ Two on-footway (plus one on-island) short wooden posts bearing miniature warning triangles have been installed. These create a potential collision hazard for cyclists and have little utility.

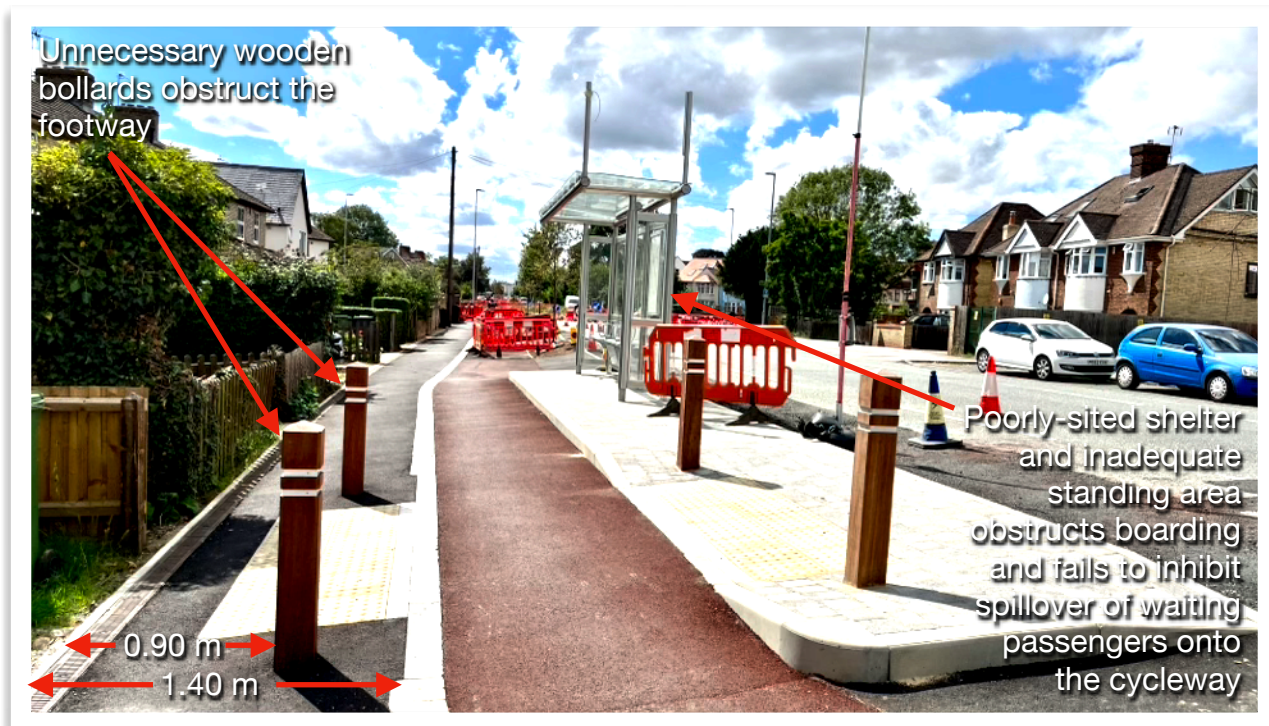
Union Lane (inbound) 0500CCITY083

- ❖ The width of the island is inadequate at 2.05 m. A user of a 'reference wheelchair' (DfT guidance) of 1.20 m length, mounting a 1.20 m manually-extended wheelchair ramp would need to reverse by approximately 0.50 m into the cycleway creating a collision hazard with cyclists.

- ❖ Siting of the shelter, with its wall close to the carriageway, set-back approximately 0.50 m, unnecessarily restricts access to buses.
- ❖ The distance, from the wall of shelter to the cycle lane, at 0.95 m, is inadequate and could lead to pedestrian spillover onto the cycleway at busy times.

- ❖ The recommended 2.00 m unobstructed width of footway is not met, being only 1.40 m (where not obstructed by street furniture).
- ❖ Unnecessary wooden bollards obstruct the footway, further reducing footway width from 1.40 m to 0.90 m. *(The bollards on the footway have since been removed.)*

- ❖ The wall of the shelter should back onto the cycle track, not the carriageway, to facilitate boarding and to inhibit spillover of waiting passengers onto the cycleway at busy times.
