Bus stop infrastructure – siting and design

Joint position paper from Cambridge Area Bus Users and Living Streets Cambridge

Standard bus stop: good design & infrastructure

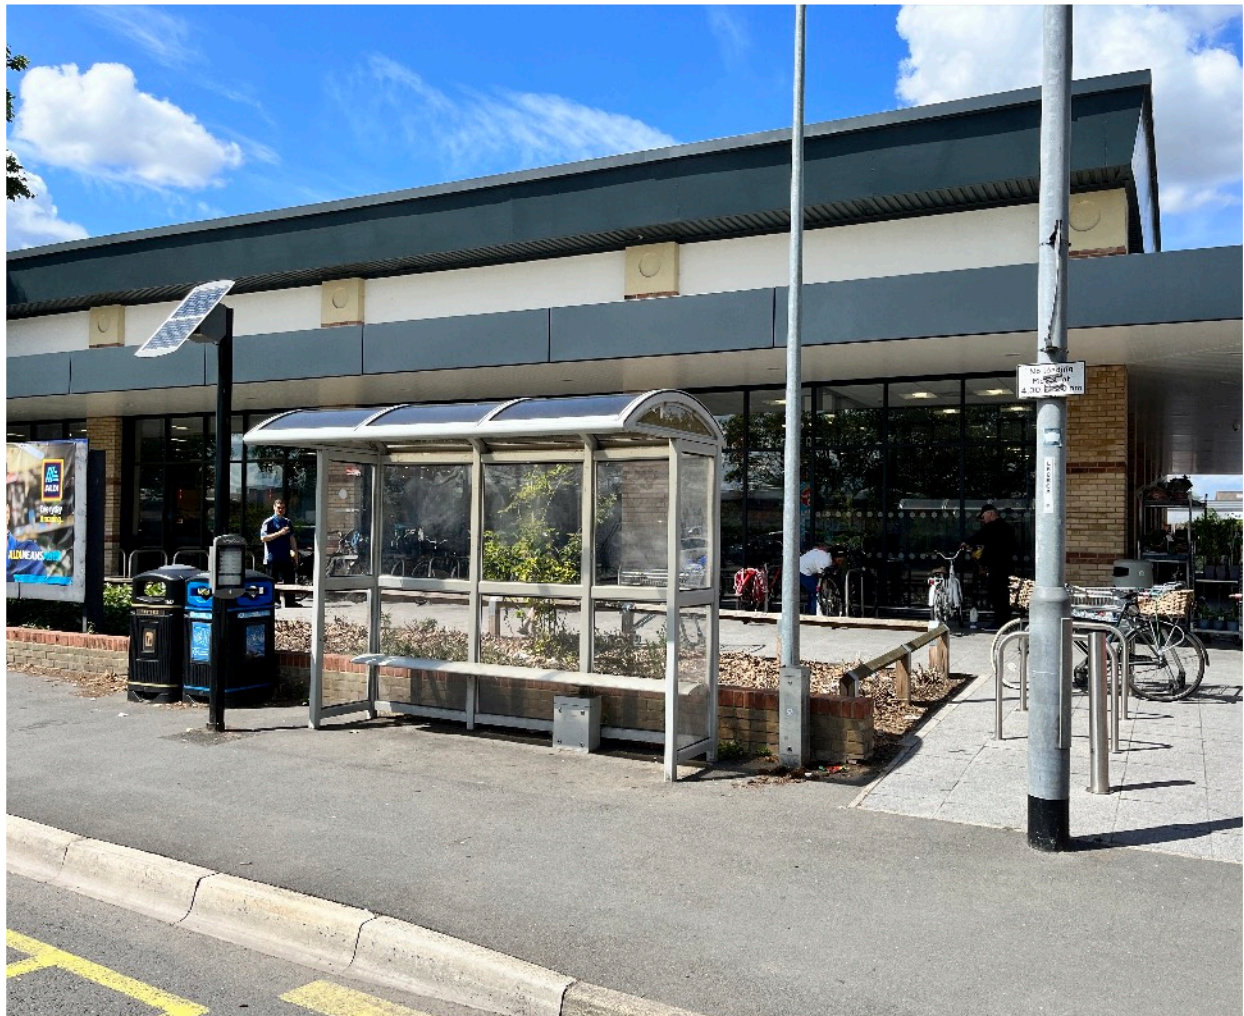
Stanley Road (outbound) 0500CCITY165 (outside Aldi, Newmarket Road)

- ❖ The shelter, with integral seating, is set back at the edge of the highway boundary.
- ❖ A bus stop flag has been mounted on an adjacent street-lighting column.
- ❖ RTPI, of e-paper type, is installed close to the shelter at the upstream end.
- ❖ There are no obstructions for passengers boarding/alighting.
- ❖ Well-sited litter bins do not obstruct pedestrians.
- ❖ Overall installation gives good access to accommodate a 'reference wheelchair' (DfT guidance) of 1.20 m length and deploying the associated 1.20 m manually-extended bus-mounted wheelchair ramp.

- ❖ There should be a lockable case for printed route/timetable information.

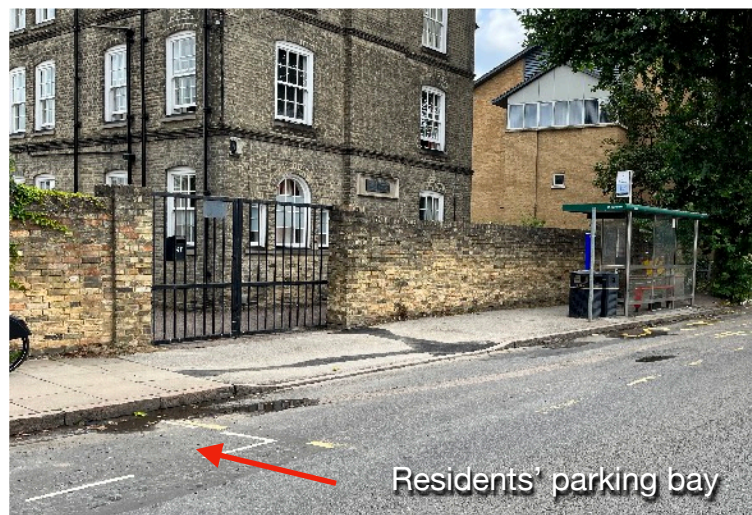
Napier Street (outbound) 0500CCITY102

- ❖ The shelter is adjacent to the bus stop carriageway-markings. However boarding from the downstream end would be difficult because of a nearby tree, which ‘bushes’ near its base in the growing season.
- ❖ At the upstream end of the shelter boarding/ alighting is obstructed by a litter bin, a recycling bin and a redundant bus stop pole with no flag.
- ❖ A nearby residents’ parking bay, upstream, prevents buses pulling in close to and parallel to the kerb, creating difficulties for boarding, especially for users of walking aids and wheelchairs.

- ❖ A shelter with integral seating is provided.
- ❖ Siting of the RTPI display is integral at the upstream end of the shelter.
- ❖ There is a bus stop flag affixed to the upstream end of the shelter.
- ❖ A lockable case for printed route/timetable information is provided.

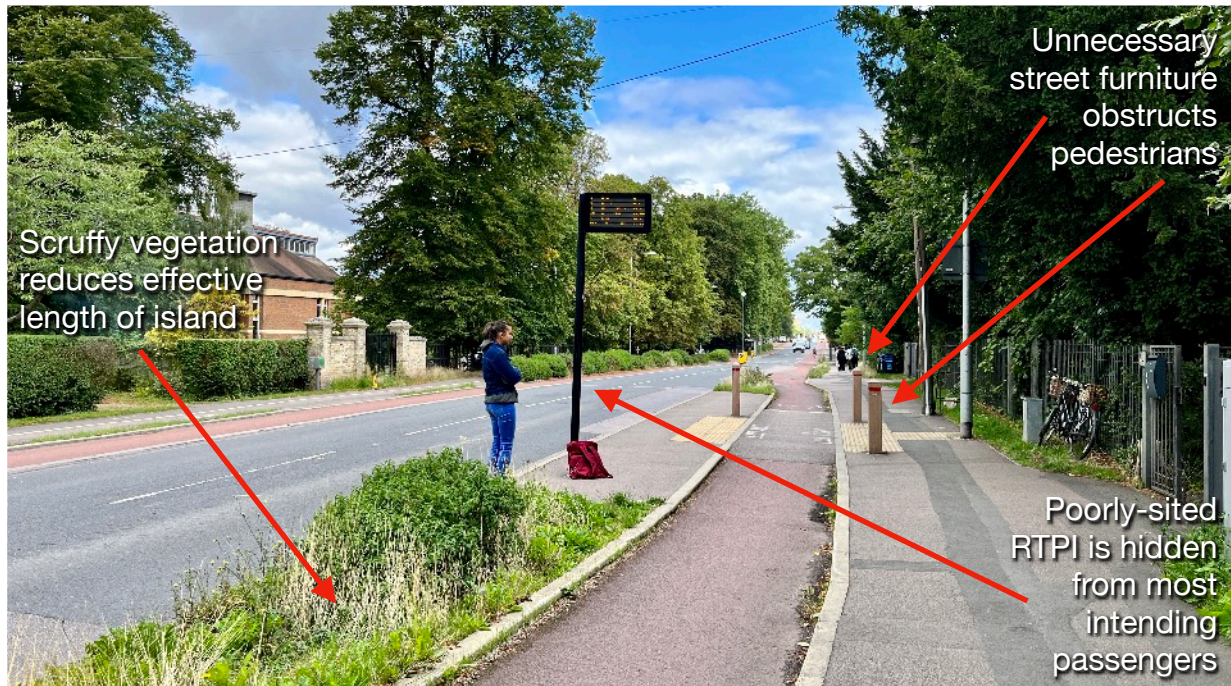
Blinco Grove (outbound) 0500CCITY036

- ❖ The width of the island is inadequate at 1.90 m. A user of a 'reference wheelchair' (DfT guidance) of 1.20 m length, mounting a 1.20 m manually-extended wheelchair ramp would need to reverse by approximately 0.50 m into the cycleway creating a collision hazard with cyclists.

- ❖ The length of the island – further reduced by rather untidy 'decorative' planting – is inadequate for a stop served by around 15 buses per hour.
- ❖ The island's area is inadequate for accommodating peak-time waiting passengers.

- ❖ The RTPI display, at the downstream end of the island, facing downstream, close to the 'decorative' planting, makes consulting the RTPI display difficult.

- ❖ No shelter or seating is provided.
- ❖ Navigating the crossing point for pedestrians from the footway is compromised by street lighting column L91SAN, a nearby wooden telecoms post and two on-footway (plus one on-island) short wooden posts bearing miniature warning triangles. These create a potential collision hazard for cyclists with little utility.

- ❖ The siting of this stop adjacent to street lighting column L91SAN and the installation of the two short on-footway wooden posts create a chicane-effect obstruction for wheelchair users.

- ❖ The footway width (2.00 m minimum upstream and downstream of the stop) is reduced by these hazards to 1.60 m (by upstream post) 1.75m (by street lighting column L91SAN) and 1.50 m (by downstream post).

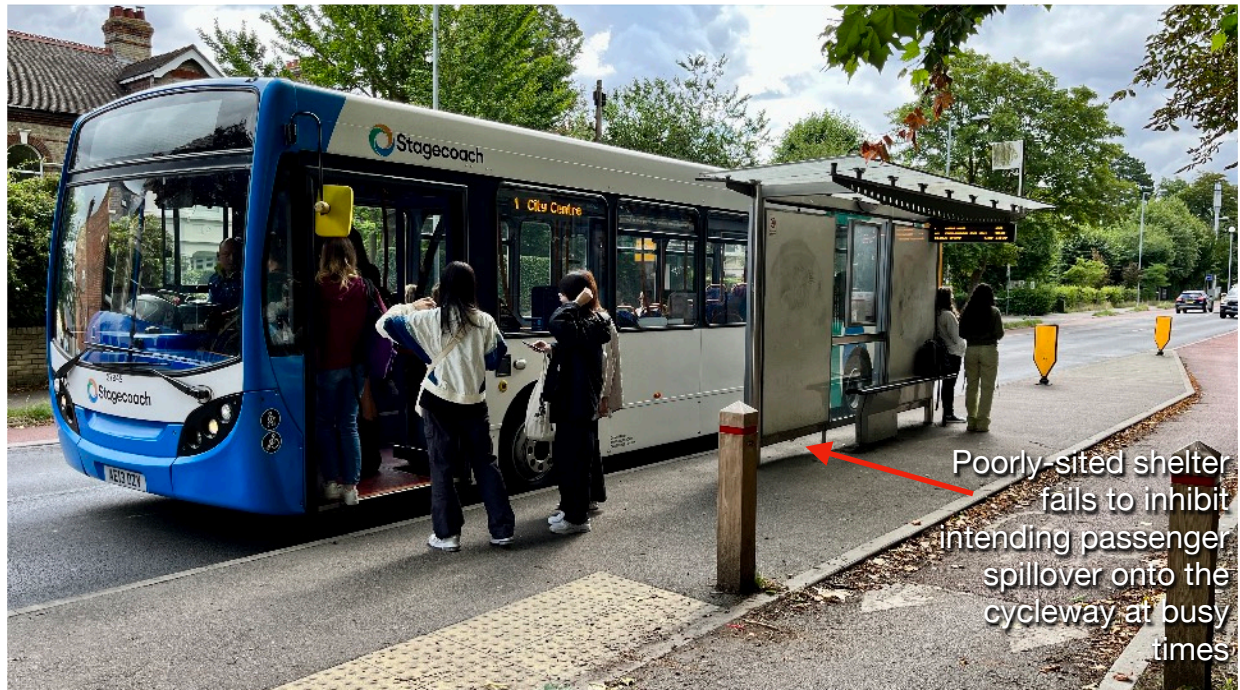
Blinco Grove (inbound) 0500CCITY064

- ❖ The length of the island is suitable for a stop served by around 15 buses per hour.
- ❖ The island's width can accommodate peak-time waiting passengers.
- ❖ A shelter, with integral seating, is provided.
- ❖ The shelter has an integrally-mounted RTPI display at the upstream end.
- ❖ Boarding is possible upstream and downstream of the shelter to accommodate two simultaneous arrivals.
- ❖ The shelter has an integral pole and bus stop flag at the upstream end.

- ❖ Siting of the shelter, with its wall close to the carriageway, set-back approximately 0.50 m, unnecessarily restricts access to buses.
- ❖ The wall of the shelter should back onto the cycle track, not the carriageway, to facilitate boarding and to inhibit spillover of waiting passengers onto the cycleway at busy times.
- ❖ The shelter's integral pole and bus stop flag is unused.
- ❖ An unnecessary pole and flag has been installed on the downstream end of the island.
- ❖ Two on-footway (plus one on-island) short wooden posts bearing miniature warning triangles have been installed. These create a potential collision hazard for cyclists and have little utility.

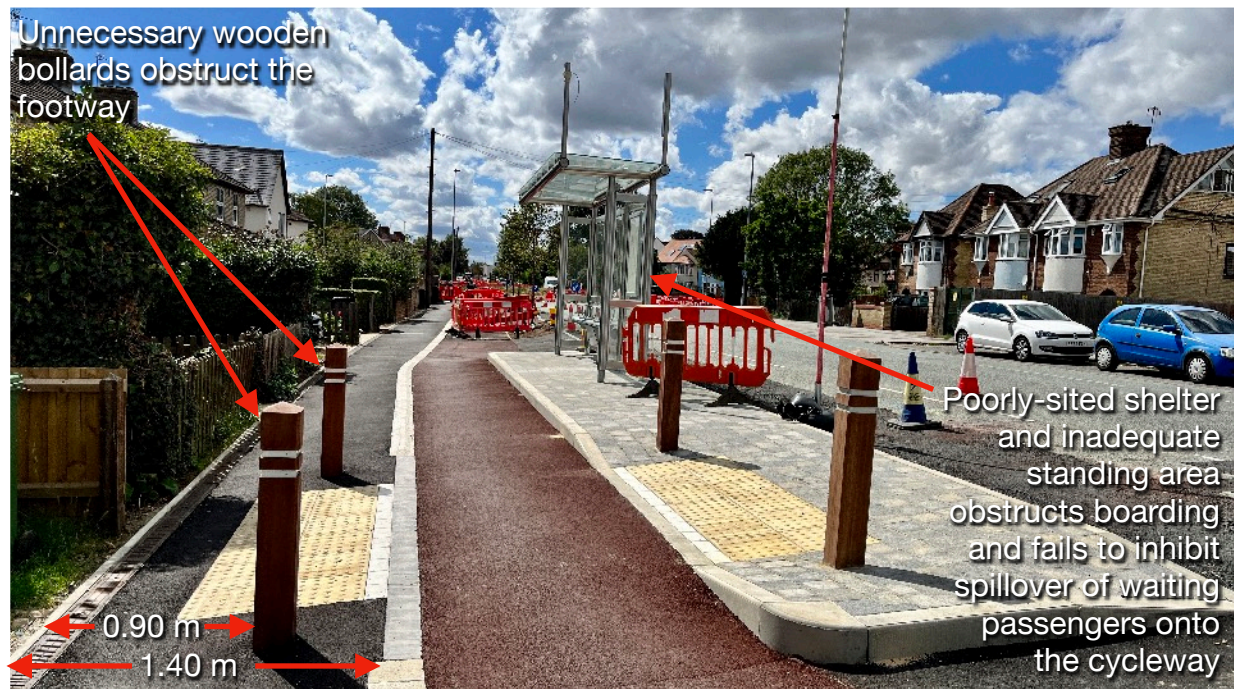
Union Lane (inbound) 0500CCITY083

- ❖ A shelter, with integral seating, is provided, at the downstream end of the island.
- ❖ The shelter has an integral pole and bus stop flag at the upstream end.
- ❖ A lockable case for printed route/timetable information is provided.
- ❖ Hopefully RTPi will be installed.

- ❖ The width of the island is inadequate at 2.05 m. A user of a 'reference wheelchair' (DfT guidance) of 1.20 m length, mounting a 1.20 m manually-extended wheelchair ramp would need to reverse by approximately 0.50 m into the cycleway creating a collision hazard with cyclists.

- ❖ Siting of the shelter, with its wall close to the carriageway, set-back approximately 0.50 m, unnecessarily restricts access to buses.
- ❖ The distance, from the wall of shelter to the cycle lane, at 0.95 m, is inadequate and could lead to pedestrian spillover onto the cycleway at busy times.

- ❖ The recommended 2.00 m unobstructed width of footway is not met, being only 1.40 m (where not obstructed by street furniture).
- ❖ Unnecessary wooden bollards obstruct the footway and bus stop island, further reducing footway width from 1.40 m to 0.90 m.

- ❖ The wall of the shelter should back onto the cycle track, not the carriageway, to facilitate boarding and to inhibit spillover of waiting passengers onto the cycleway at busy times.
